NPIC/R-90/64

February 1964

PHOTOGRAPHIC INTERPRETATION REPORT

SA-1 SAM SITES, MOSCOW, USSR, SOUTHEAST QUADRANT

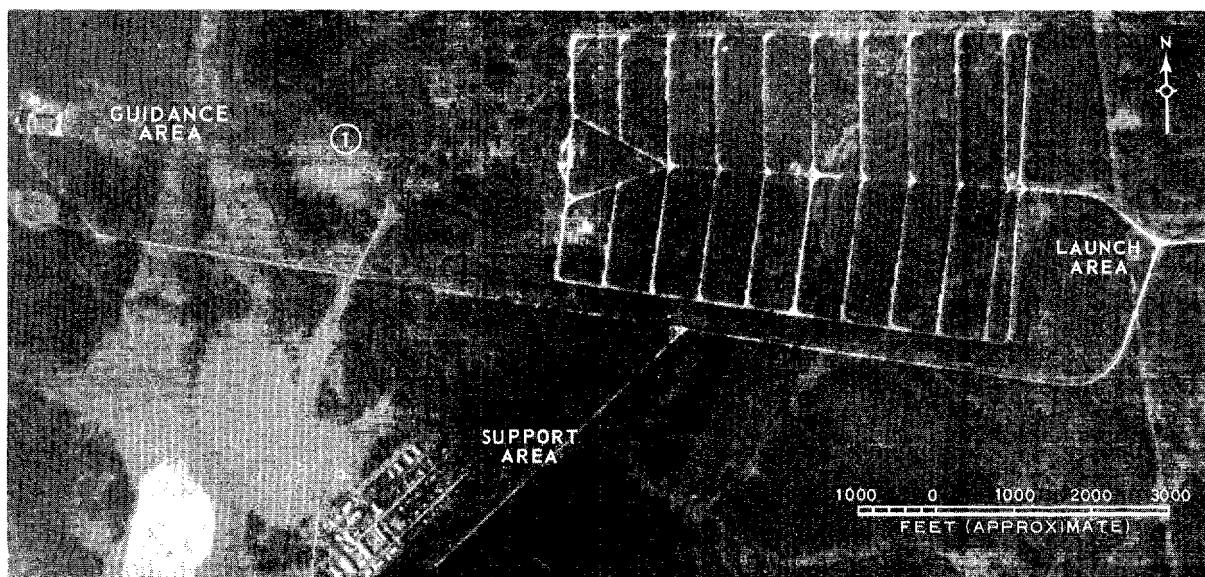
FIGURE 2. MOSCOW SAM SITE C10-1, [REDACTED]

The first clear coverage of the site on KEYHOLE photography was in [REDACTED] at which time the site was complete. At that time, a small unidentified building (Figure 2, Item 1) was observed in a clearing midway between the guidance and launch areas. No other apparent changes were observed at the site between [REDACTED]

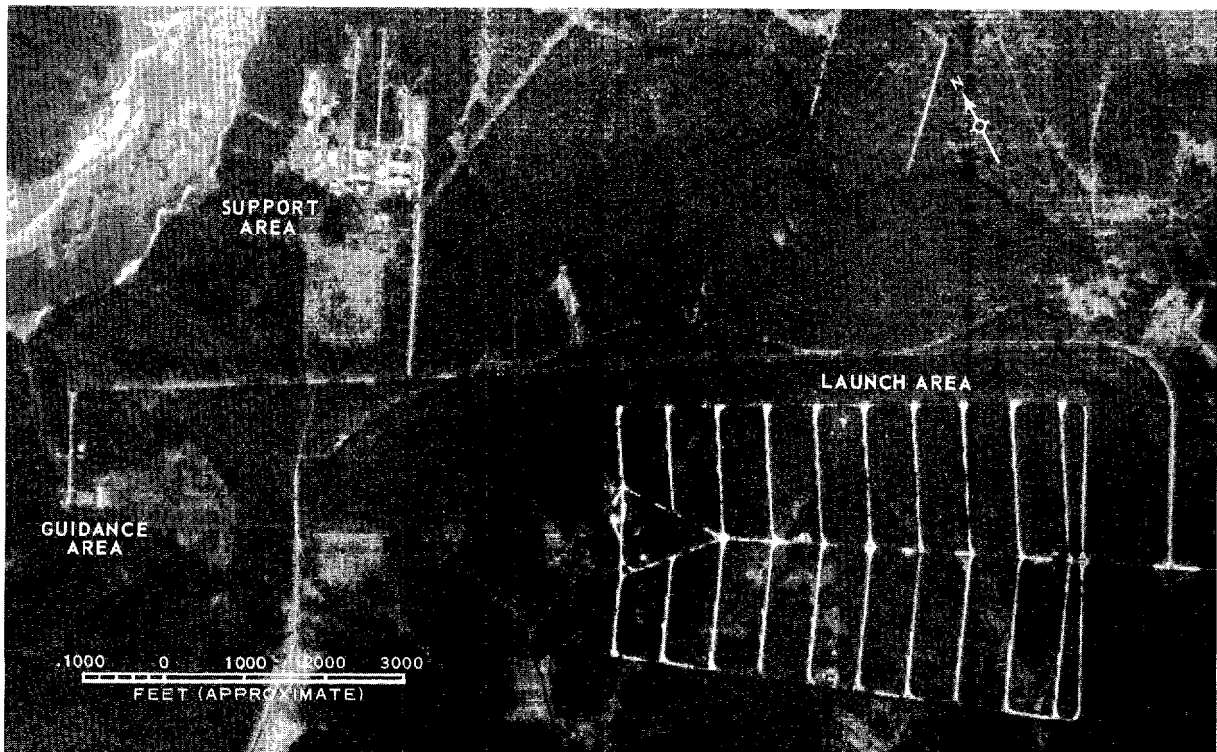
FIGURE 3. MOSCOW SAM SITE C12-1, [REDACTED]

The first clear coverage of the site on KEYHOLE photography was in [REDACTED] at which time the site was complete. No apparent changes were observed at the site between [REDACTED] (Figure 3).

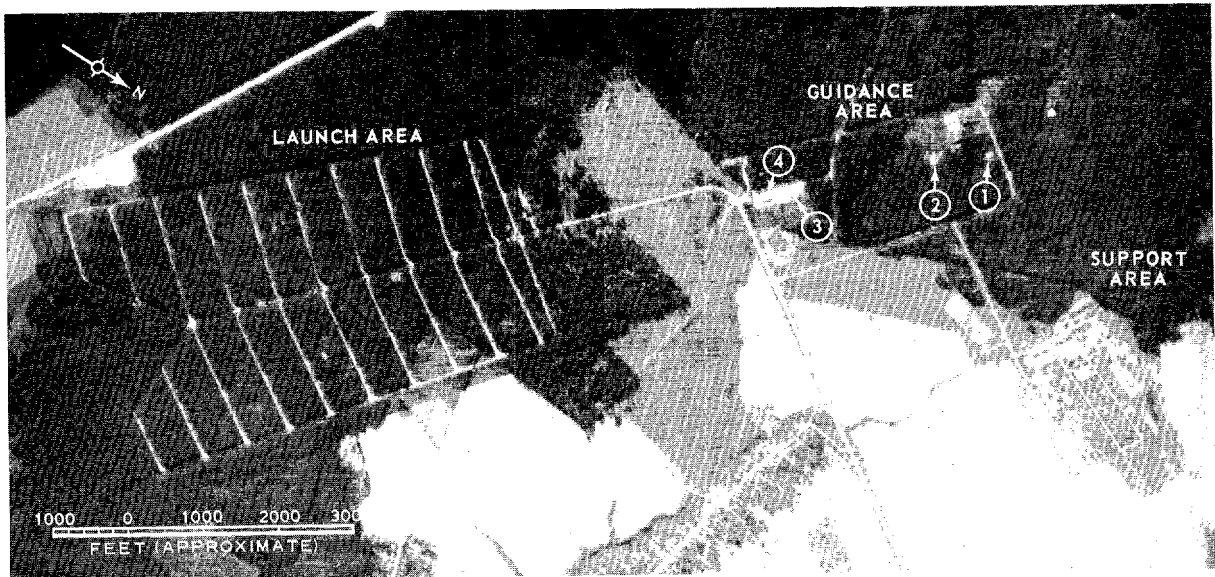
FIGURE 4. MOSCOW SAM SITE C14-1 [REDACTED]

KEYHOLE photography was in [REDACTED] at which time the site was complete. On [REDACTED] two cleared areas (Figure 4, Items 1 and 2) were first observed. Later, on [REDACTED] a third clearing (Item 3), 580 by 230 feet, containing several small structures was identified. A building (Item 4) 100 by 25 feet, which was under construction in [REDACTED] had been completed by [REDACTED]

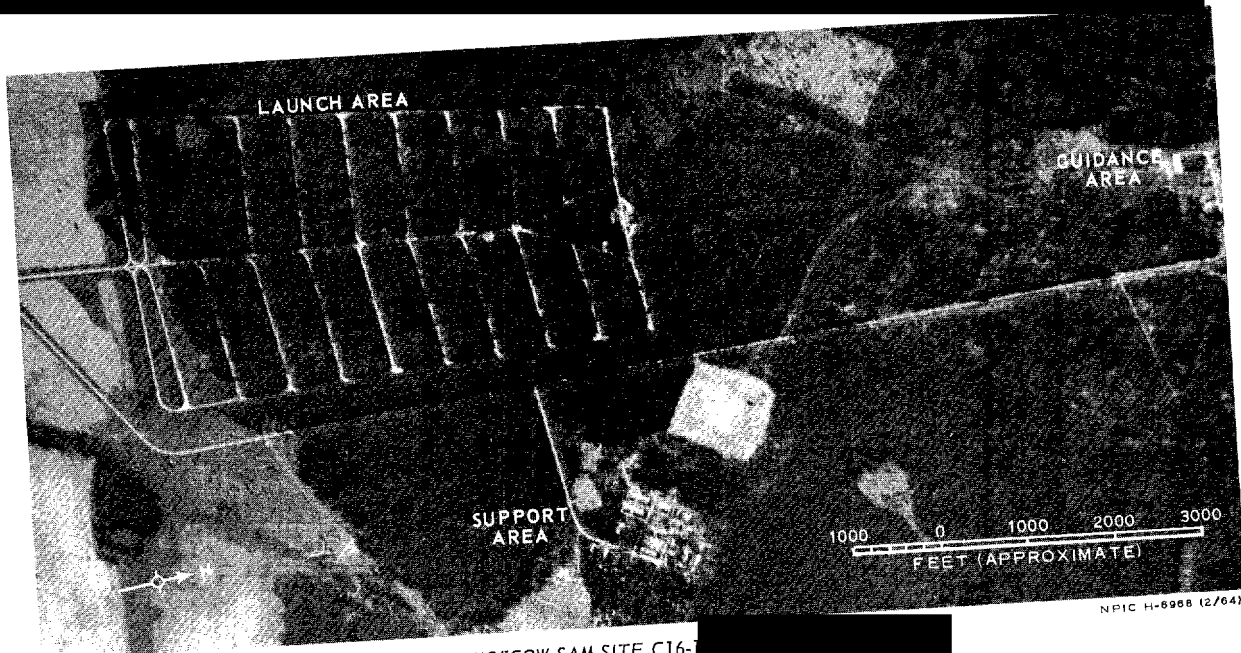
FIGURE 5. MOSCOW SAM SITE C16-1

The first clear coverage of the site on KEYHOLE photography was in at which time the site was complete. No apparent changes were observed at the site between

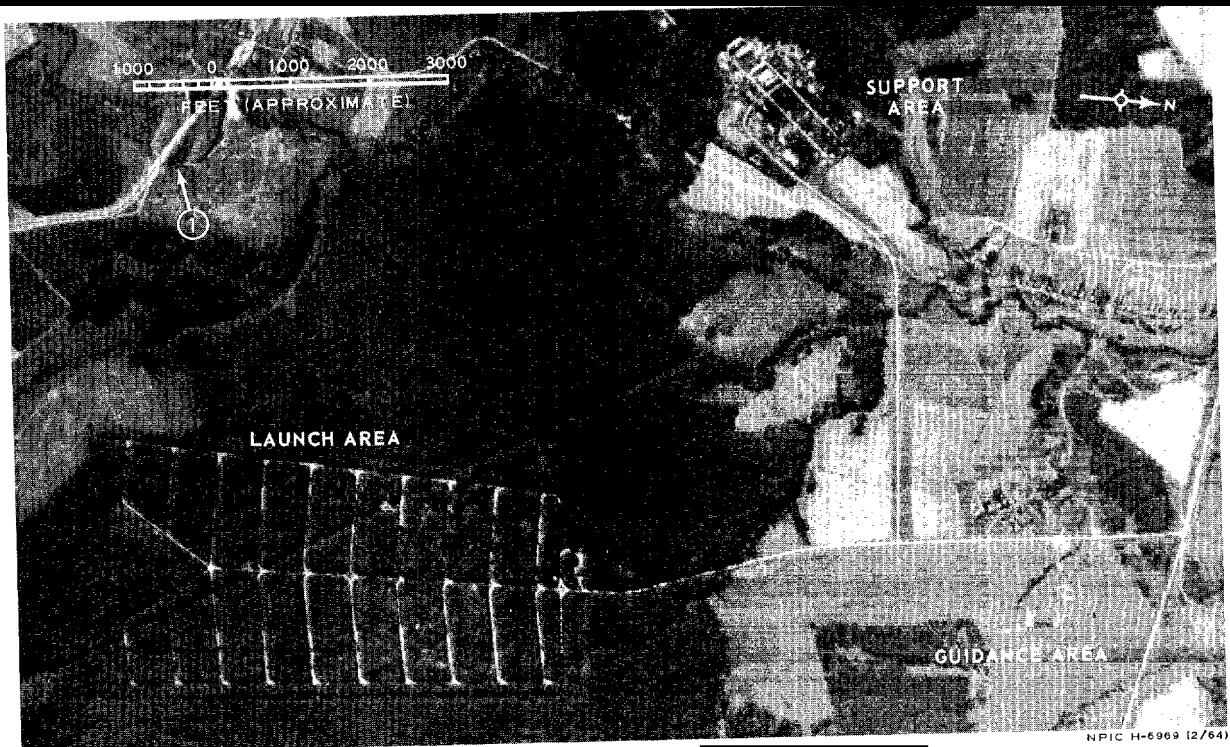
FIGURE 6. MOSCOW SAM SITE C17-1, [REDACTED]

KEYHOLE photography was in [REDACTED] at which time the site was complete. On photography of [REDACTED] a road (Figure 6, Item 1) was first observed under construction just west of the launch area. As of [REDACTED] construction of the road had progressed, but had not been completed. No apparent changes were observed at the site between [REDACTED]

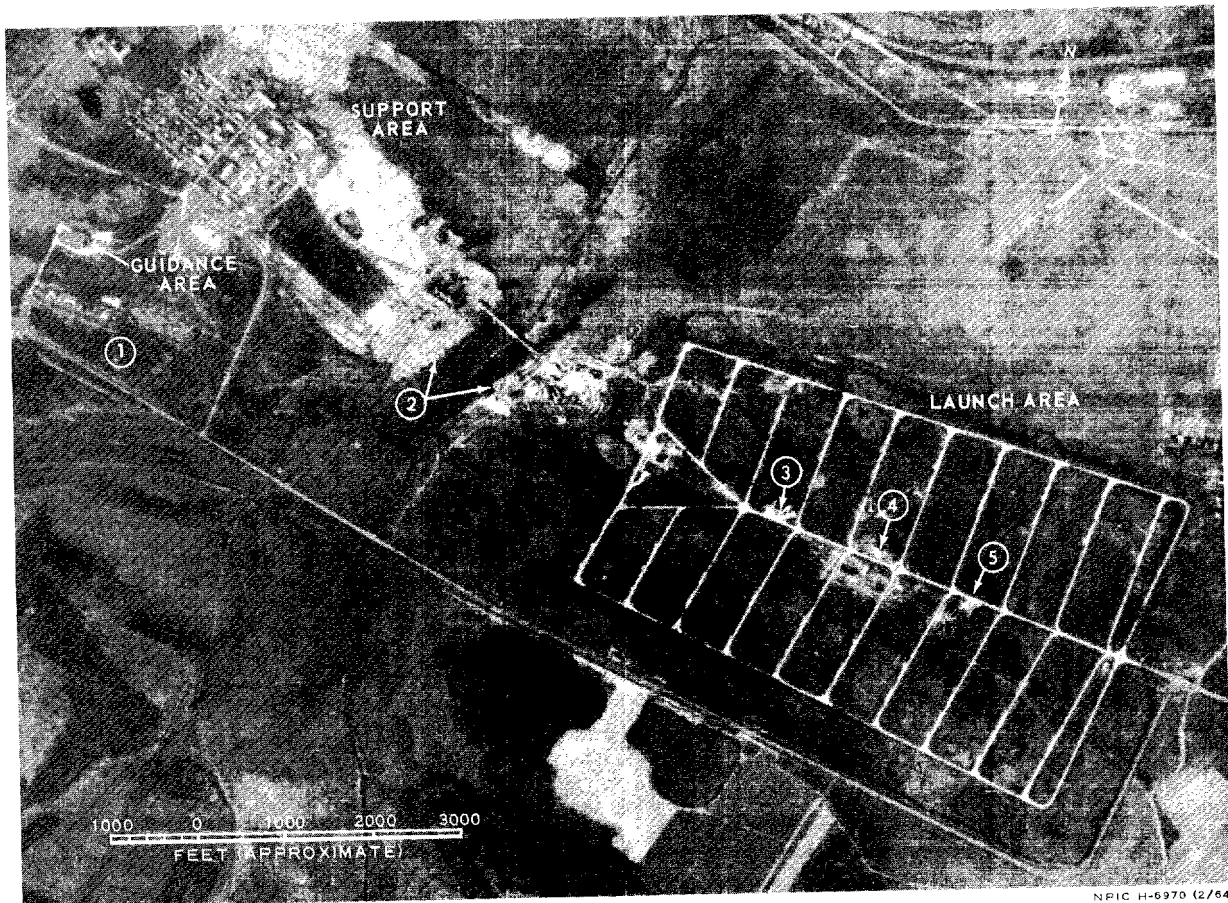
FIGURE 7. MOSCOW SAM SITE E10-1, [REDACTED]

three large warehouse-type buildings and several smaller, unidentified buildings (Figure 7, Item 1) were observed just south of the guidance area. In addition, an area of disturbed earth, but without any discernible structures, was observed on both sides of a stream (Item 2). Later, in [REDACTED] two additional areas (Items 3 and 5) of disturbed earth and one small unidentified building (Item 4) were observed. No apparent changes were observed at the site between [REDACTED]

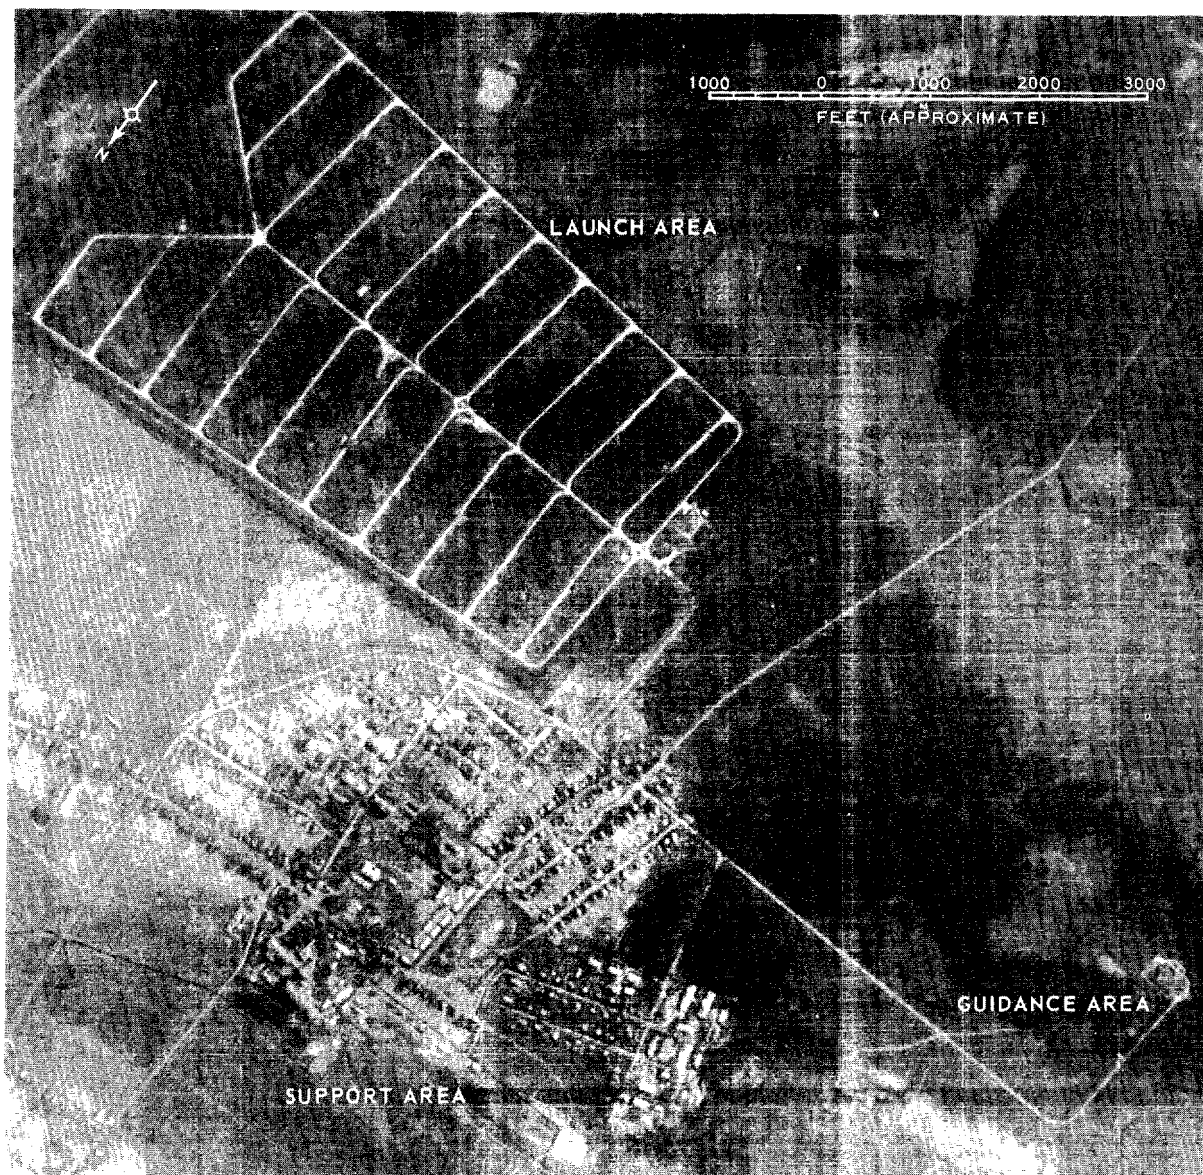
FIGURE 8. MOSCOW SAM SITE EA10-7, [REDACTED]

at
which time the site was complete. No apparent
changes were observed at the site between

(Figure 8).

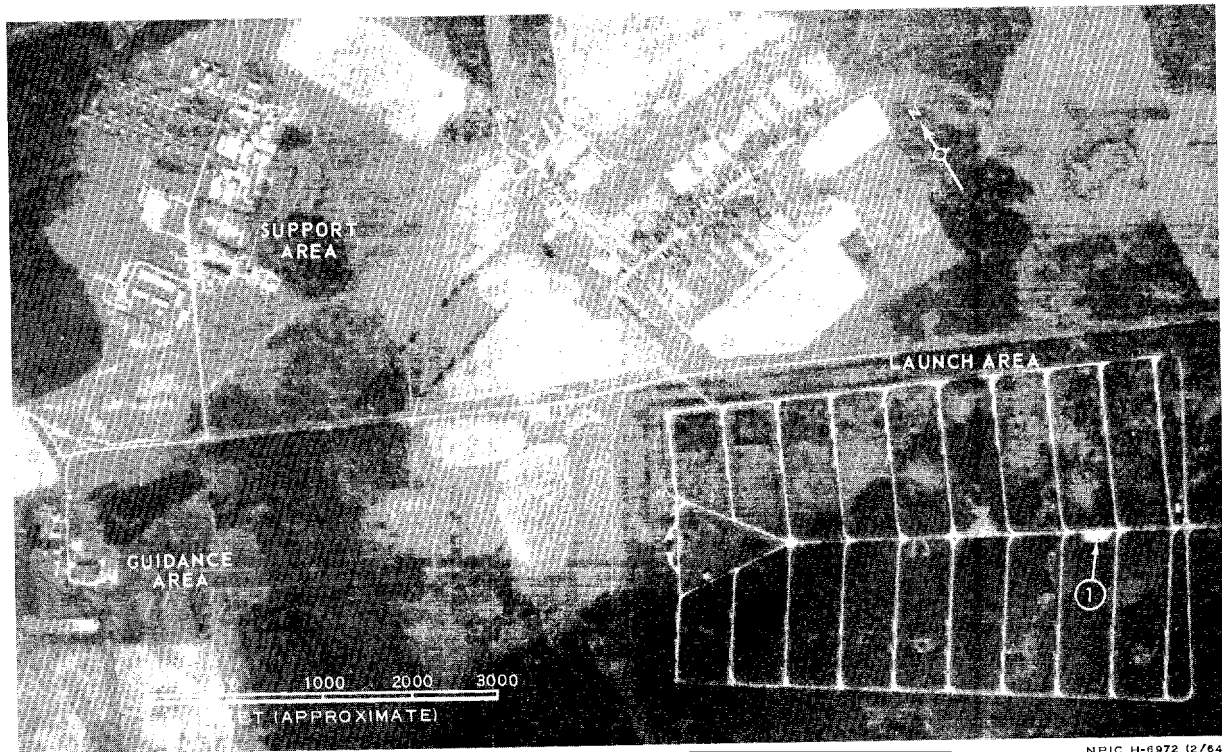
FIGURE 9. MOSCOW SAM SITE E12-1

The first clear coverage of the site on
KEYHOLE photography was in [REDACTED] at
which time the site was complete. Other than
minor ground scarring (Figure 9, Item 1) ob-
served at the centerline road of the launch area,
no significant changes were observed between

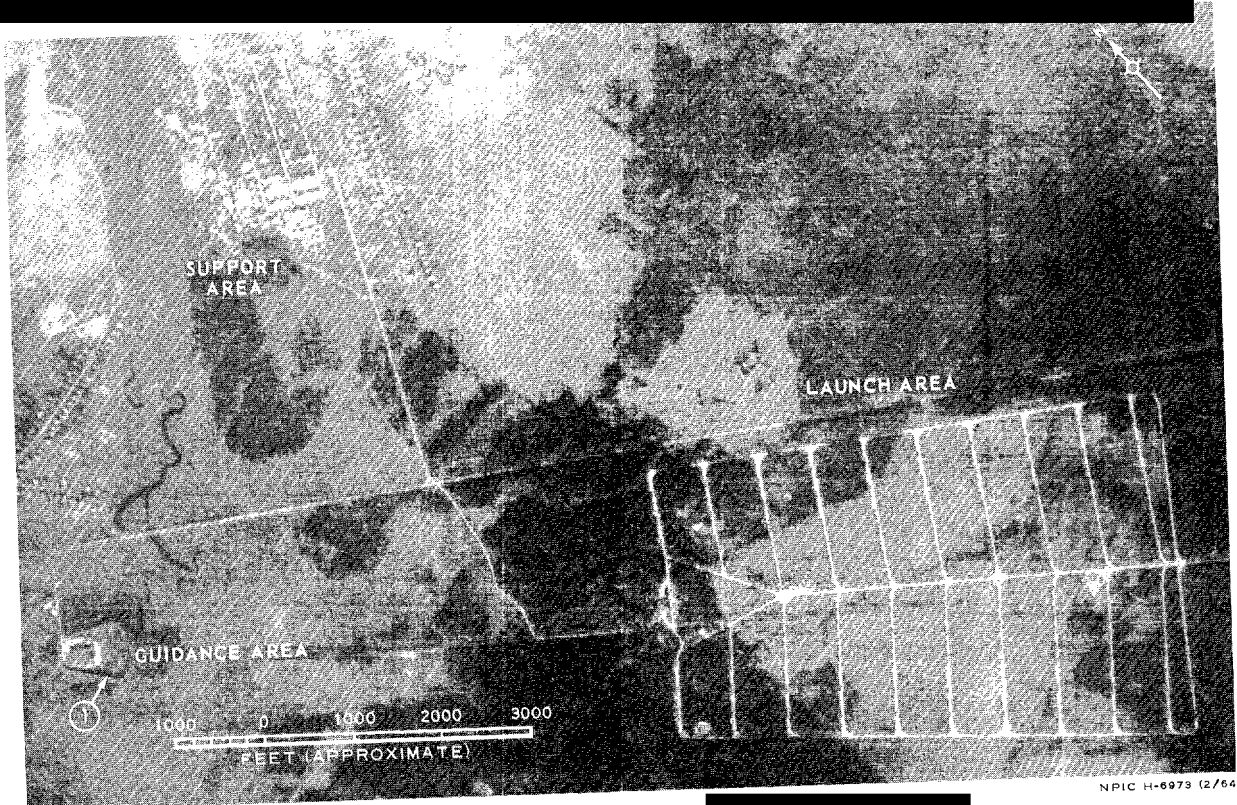
FIGURE 10. MOSCOW SAM SITE E13-1 [REDACTED]

KEYHOLE photography was in [REDACTED] at which time the site was complete. At that time, it was noted that an earthen wall (Figure 10), Item 1) had been constructed on three sides of the guidance area, possibly to prevent flooding of the area in inclement weather. No apparent changes were observed at the site between [REDACTED]

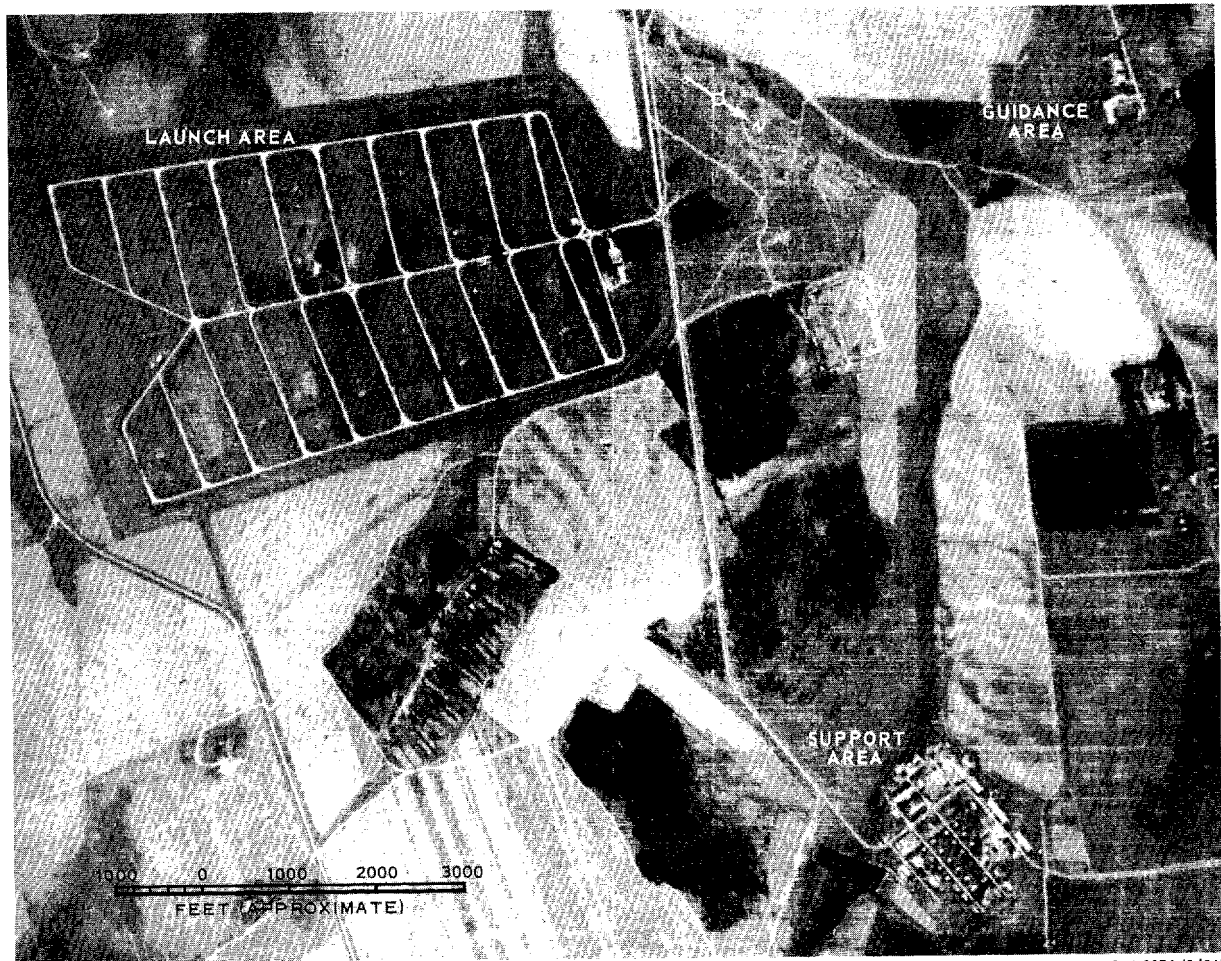
FIGURE 11. MOSCOW SAM SITE E14-1, [REDACTED]

The first clear coverage of the site on KEYHOLE photography was in [REDACTED] at which time the site was complete. No apparent changes were observed at the site between [REDACTED] (Figure 11).

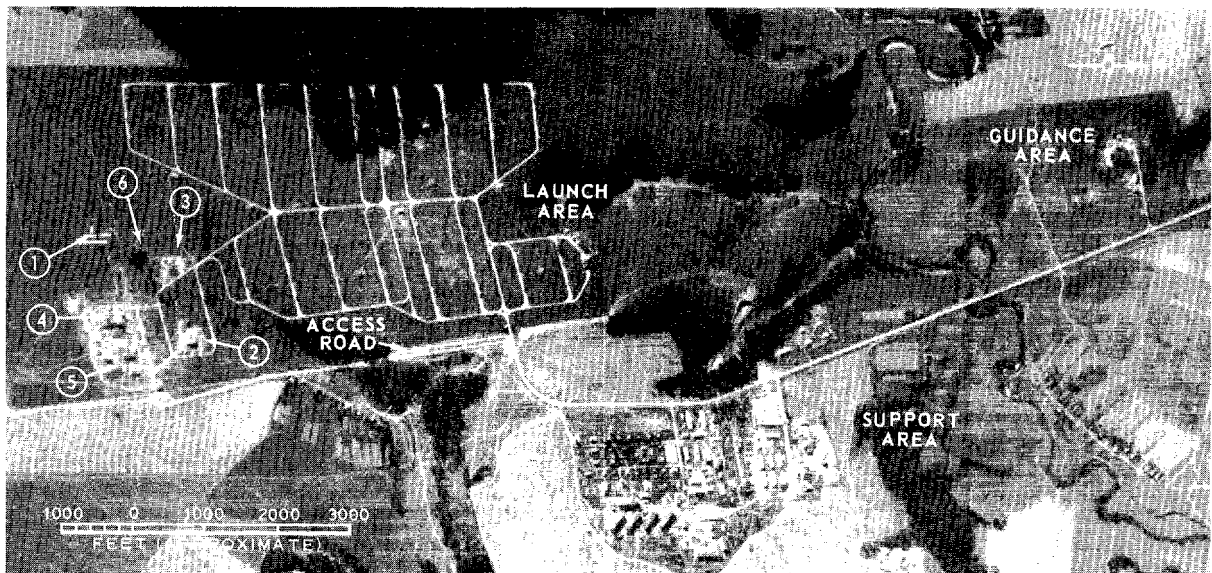
FIGURE 12. MOSCOW SAM SITE E15-1

The first clear coverage of the site on KEYHOLE photography was in [REDACTED] at which time the site was complete, but some additions were observed in the support area and the site facilities. Four large buildings, 195 by 40 feet, had been constructed in the support area and an access road was under construction parallel to the launch area. Between [REDACTED] construction activity, possibly AMM associated, was observed at the southeast corner of the launch area. In [REDACTED] a fifth 195- by 40-foot building had been added to the

support area and an unidentified ground pattern (Figure 12, Item 1) was observed near the center-line of the launch area. Later in [REDACTED] a sixth 195- by 40-foot building was identified in the support area and two buildings (Items 2 and 3), 100 by 100 feet, with objects on the roofs had been constructed at the southeast corner of the launch area. The walls of a rectangular building (Item 4) were under construction just south of the 100- by 100-foot buildings.

In addition to the above changes, four buildings (Item 5), 110 by 35 feet, 95 by 30 feet, 85 by 30 feet and 55 by 25 feet, had been observed under construction on [REDACTED] photography. These buildings were completed by [REDACTED] the rectangular building 225 by 125 feet (item 4) had been completed and a plus-configuration scar (Item 6), possibly ditching for cable connections, was observed at the south side of the launch area.

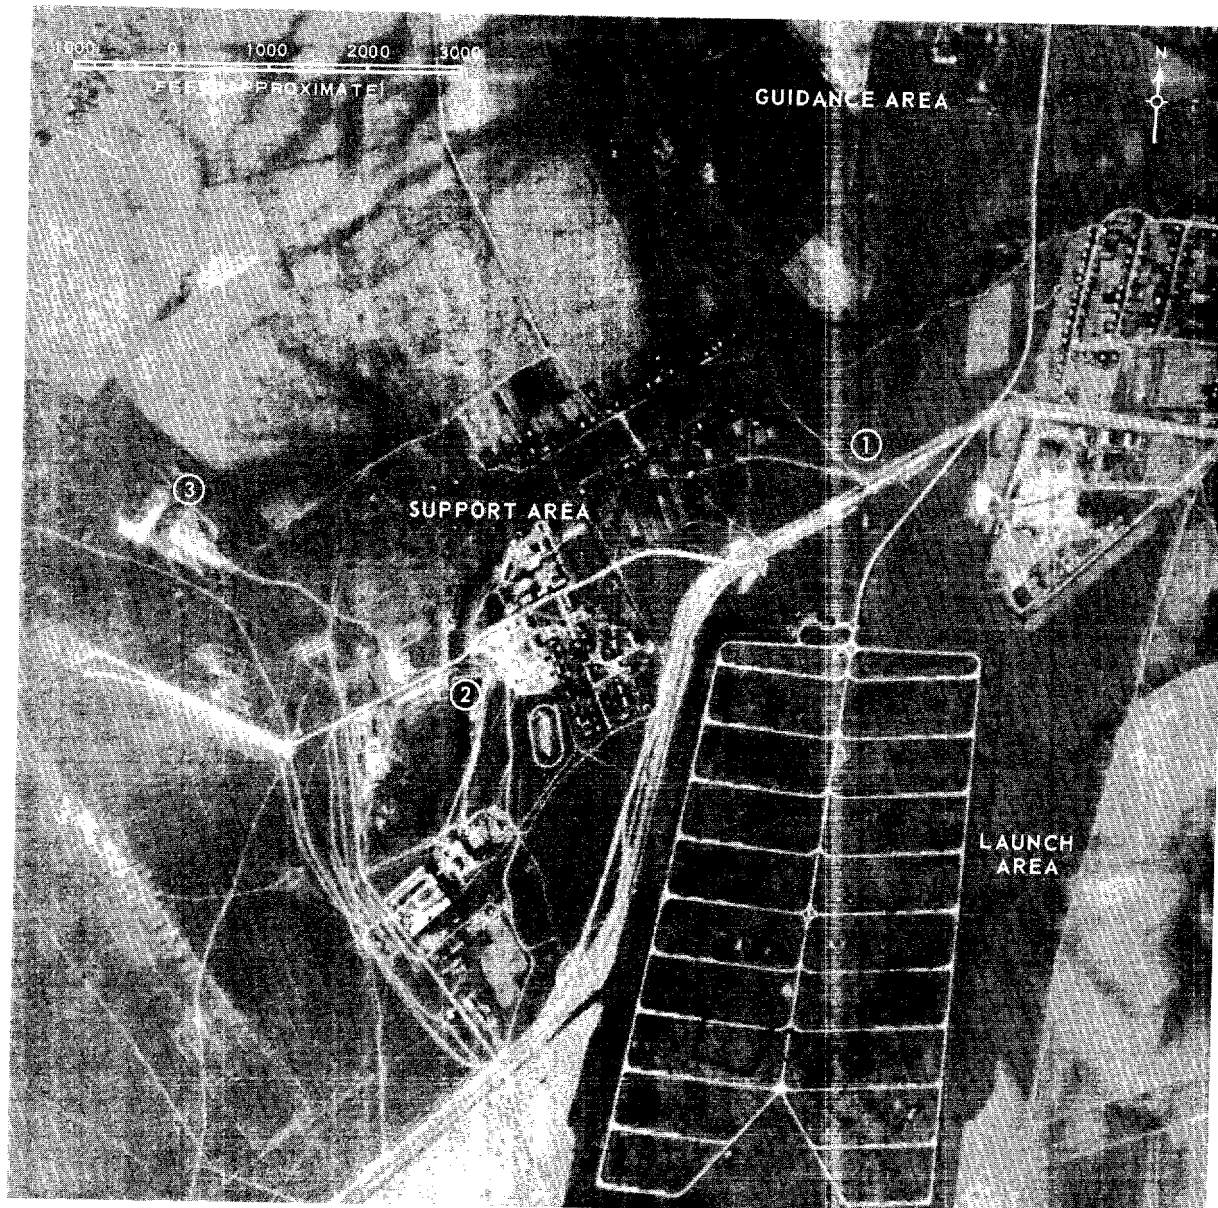
FIGURE 13. MOSCOW SAM SITE E16-1, [REDACTED]

The first clear coverage of the site on
KEYHOLE photography was in [REDACTED] at
which time the site was complete. At that time,
a road (Figure 13, Item 1) was under construc-
tion. In [REDACTED] two earth scars (Items 2
and 3) were observed. No other significant
changes were observed at the site between [REDACTED]
[REDACTED]

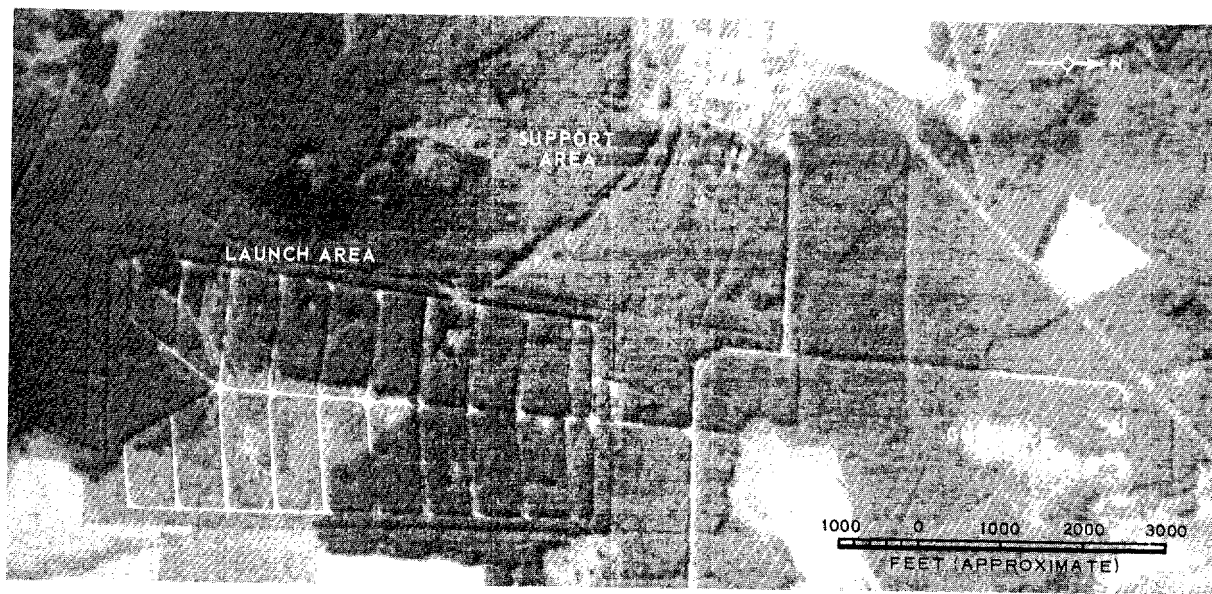
FIGURE 14. MOSCOW SAM SITE E17-1, [REDACTED]

The first clear coverage of the site on KEYHOLE photography was in [REDACTED] at which time the site was complete. No apparent changes were observed at the site between [REDACTED] (Figure 14).

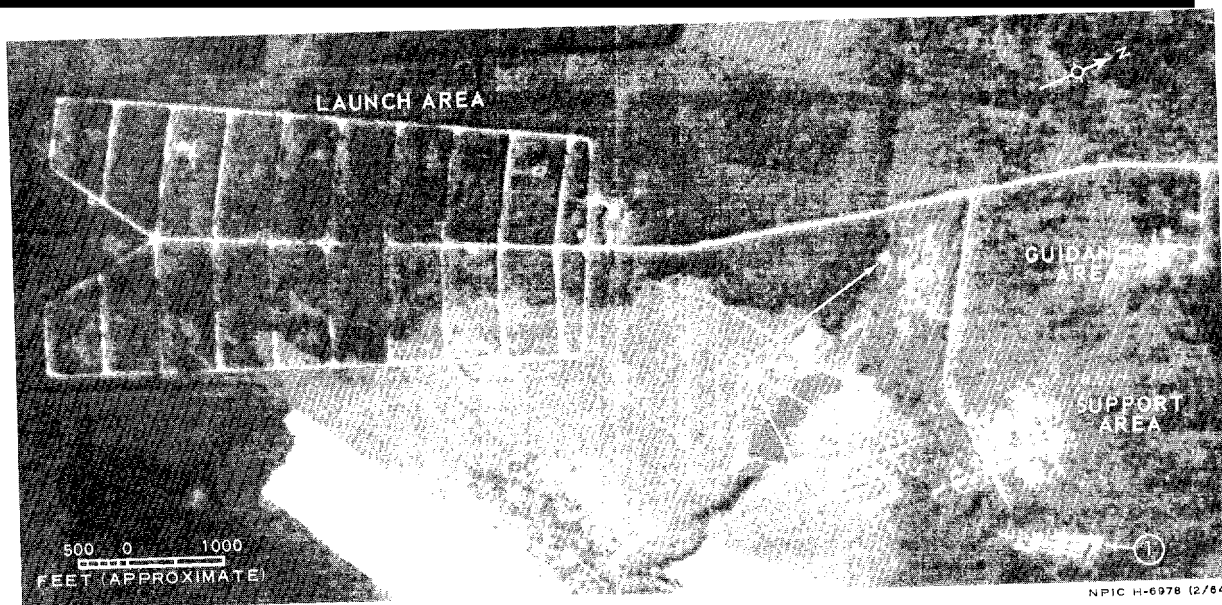
FIGURE 15. MOSCOW SAM SITE E18-1, [REDACTED]

on KEYHOLE photography was on [REDACTED] it was possible to determined from [REDACTED] photography that the site was complete. An open trench (Figure 15, Item 1), which may be a possible small arms range, and several earth scars (Item 2) were also observed on [REDACTED] photography. No apparent changes were observed at the site between [REDACTED]
